EVALUATION THE EFFECT OF HYDROFLUORIC ACID AND GRINDING TREATMENT ON SHEAR BOND STRENGTH OF IPS E.MAX PRESS WITH CERAMIC VENEER MATERIAL (AN IN VITRO STUDY)

¹*Shurooq F. Hasan and ²Akhlas Z. Abood

KEYWORDS: Lithium Di-Silicate, Surface Roughness, Shear Bond, Grinding.

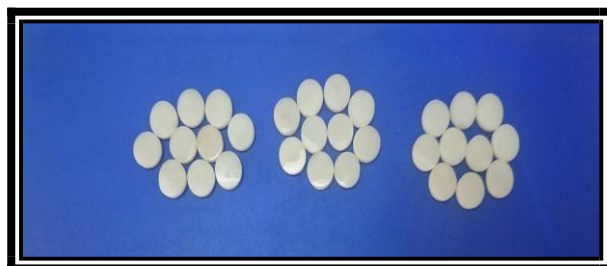
Fig. (1): three groups of 30 ceramic discs.

order to obtain flat surface for standardization only one surface of the specimen was polished first with wet 600 then with wet 1200 grit silicon carbide abrasive paper this procedure done with 500rpm in Grinder-Polisher device(Mapao 160E,China) under running water. After that, cleaning the samples in an ultrasonic cleaning device for 10 min and air dried **fig (1)**.

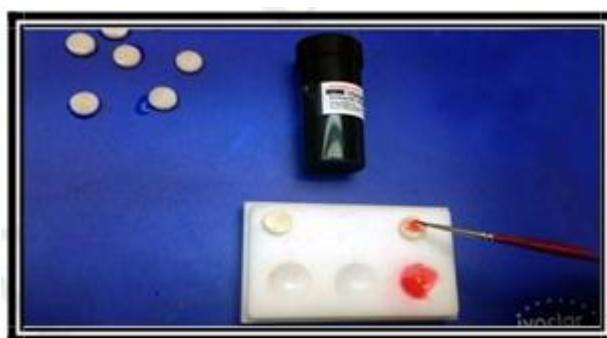
Fig. (2): applying HF acid on the surface of the sample.

Group 2: etching with 4.5%HF acid each sample of this group treated by etching with one drop of 4.5%hydroflueic acid gel (Lot no.T47018, Ivoclarvivadent, Liechtenstein) by using a fine brush the drop of HF can be applied on the polished surface of the specimen **Fig(2)**.

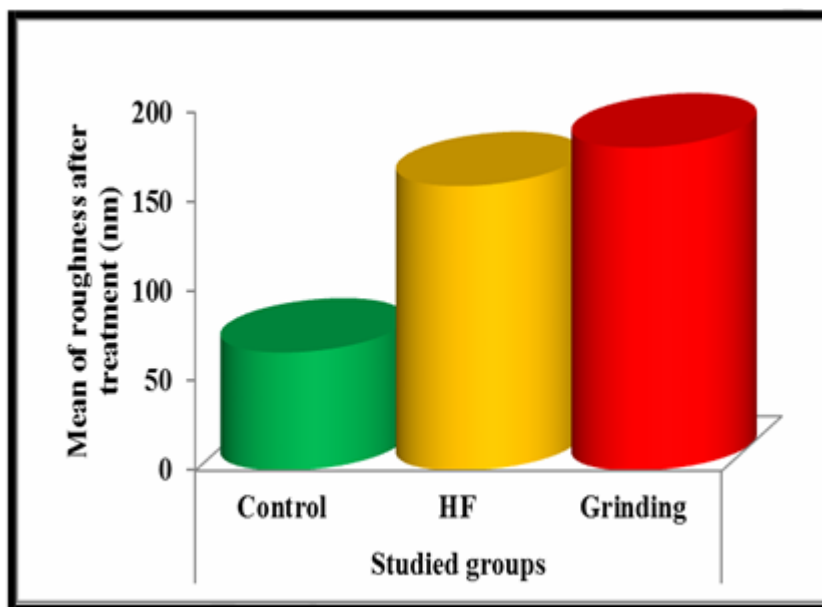
Figure (6): mean distributions of roughness after treatment (nm) according to studied groups.

Mean surface roughness value (nm) after treatment are presented in table (3) and graphically illustrated in fig(6).One-way ANOVA test revealed that there were a variation between the mean of studied groups control (without treatment) (66.063+2.977),grinding (180.562 +13.557) was elevated followed by HF(159.062+30.995),with a highly significant difference(ANOVA test : $p=0.00$, $p<0.01$).

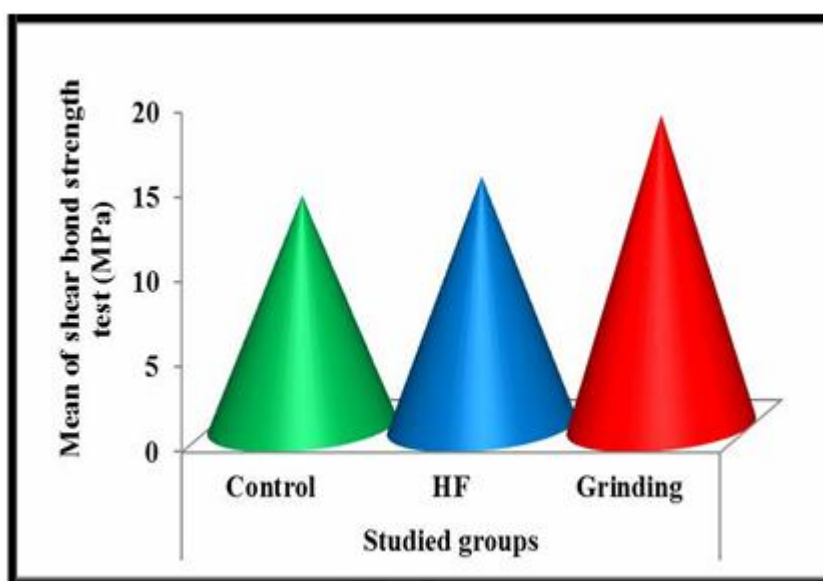
Figure (10): mean distributions of Shear bond strength test (MPa) among studied groups.

Data documented in table (6) noted a highly significant difference (ANOVA test: $p=0.00$, $p<0.01$) control (13.59+3.79), HF (14.72 +3.15), and the grinding (18.34+3.63) and graphically illustrated in fig (10).followed that the least significant difference test(LSD test) to estimate the source of difference between the groups table (7) showed a non –significant difference when compare between control Vs. HF ($p=0.581$, $p >0.05$), HF Vs. grinding($p=0.076$, $p>0.05$), and significant difference when compare between control Vs. grinding ($p=0.022$, $p<0.05$).

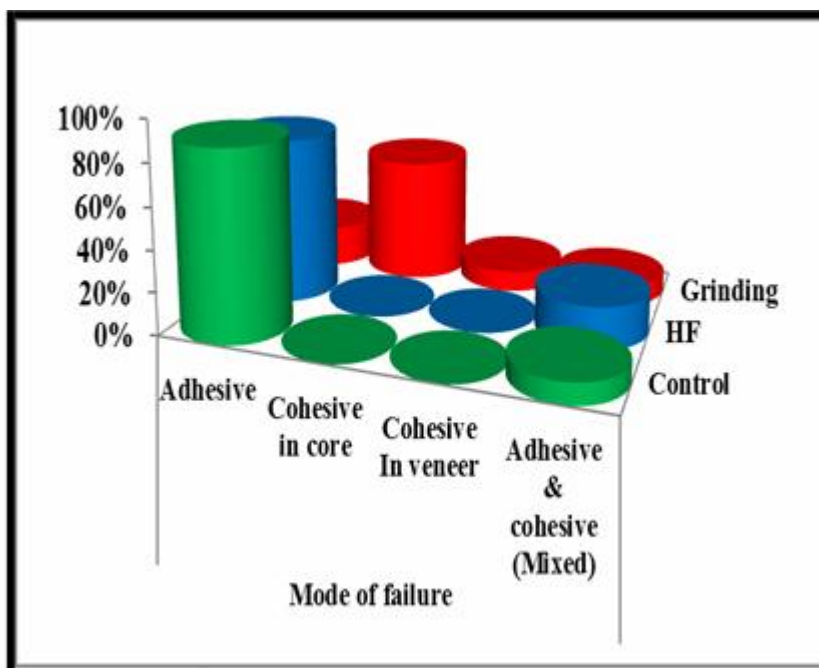
Figure (13): Distribution of mode of failure test according to studied groups.

Bond failure analysis: Distinct distribution of failure modes among the groups were found, as is shown in table (10), fig(13), revealed that the best groups were **grinding** {Adhesive (**2**, **20%**), Cohesive in core (**6**, **60%**), Cohesive in veneer (**1**, **10%**) & Mixed - Adhesive & Cohesive (**1**, **10%**). While, and the vice versa in control {Adhesive (**9**, **90%**), Cohesive in

core (0%), Cohesive in veneer (0%) & Mixed - Adhesive & Cohesive (1, 10%)} & Finally, HF {Adhesive (8, 80%), Cohesive in core (0%), Cohesive in veneer (0%) & Mixed - Adhesive & Cohesive (2, 20%)}

The mode of failure **table (10), fig (13)** should be considered in studying the quality of bond and should not depend on the bond strength data alone.
